**Second  
International Conference  
on  
Case Histories in  
Geotechnical Engineering**

**June 1-5, 1988**

**University of Missouri-Rolla  
Rolla, Missouri**

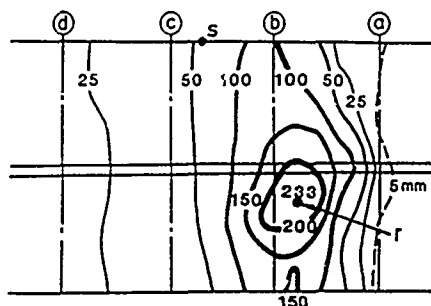
Prior to the removal of test load on 20/7

6/6 to 17/7

- (a) Stage 1 settlements had a dish-shape and appeared to have resulted from a point disturbance around point r (Figure 5). They had a stick-slip relationship with time (Figure 3a), i.e. a 'collapse' type of settlement. Calculations indicated that the 20 kPa test load could have induced up to about 10% of the total settlements in this stage.

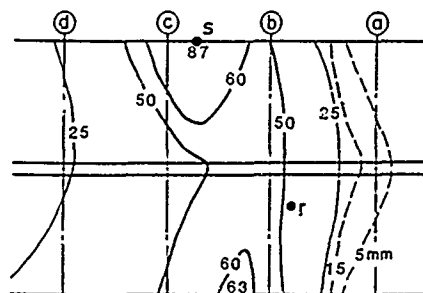
Inclined holes grouting completed on 11/9

2/9 to 12/9

- (b) Stage 2 settlements were much more rapid (Figure 3b) and were likely to be related to slope instability (Figure 6). Stability analyses of the side slopes assuming 'dry' condition, i.e. zero pore pressures, gave factors of safety in excess of 1.2. However, measurements taken in the grout holes after drilling indicated high water levels in the holes. In one of the holes, water was found to be only 5 m below the road surface. Further stability calculations using the measured 'phreatic surface' revealed factors of safety close to unity. There was heavy rainfall between 4th and 6th September. The rain could have had some effects on the slope, but it could not be the main cause of failure as the slope had survived previously harsher rainstorms.

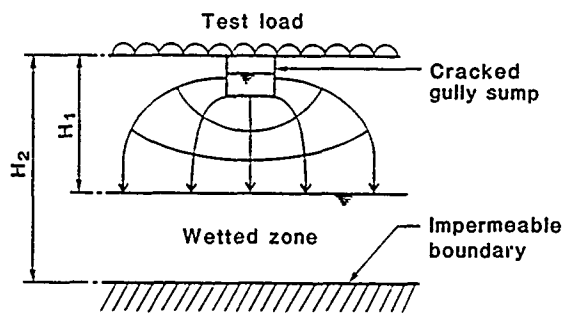
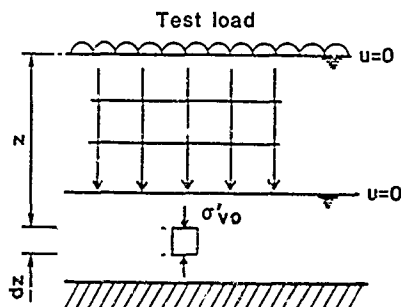
Figure 7 - Proposed hydrocompaction mechanism for collapse of loose fill

(a) Field Condition

(b) Idealised 1-D Model

stone, with some top soil and organic matter at the base of the fill. This fill/insitu ground interface would allow any descending water from the gully to perch on, thus permitting the formation of a wetted zone that can advance upwards to initiate hydrocompaction of the loose patch of fill (Figure 7). An idealised 1-D model was used to compute the order of settlement, using the oedometer test results. The following summarizes the analytical approach adopted.

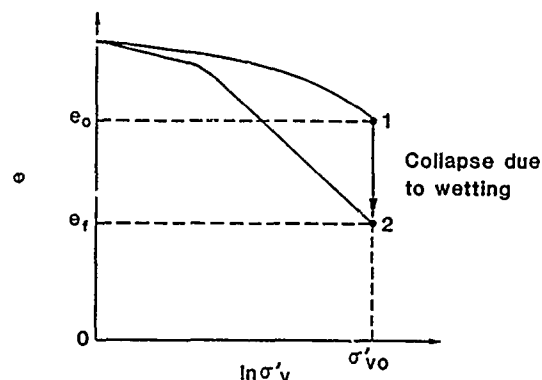
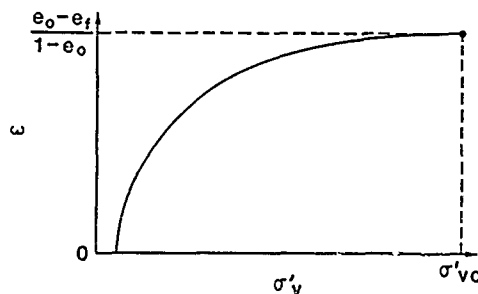
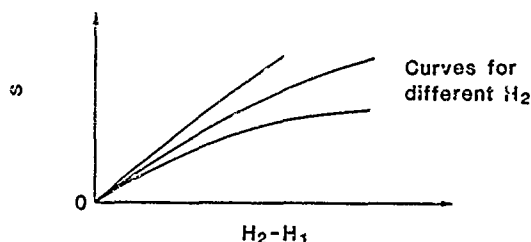
Figure 8 - Interpretation of oedometer test results

(a) Typical Wetting Test Results

(b) Strain versus Vertical Effective Stress

(c) Settlement as Function of  $H_1$  &  $H_2$

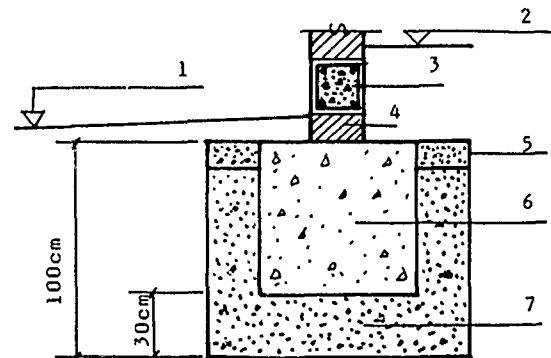
Fig. 3 Sand Cushion

In Figure 3: 1 = Outer ground surface

1. Strip foundation have been buried into 1m deep with sand cushion (Figure 3) and the two sides of foundation trough are filled with sand.

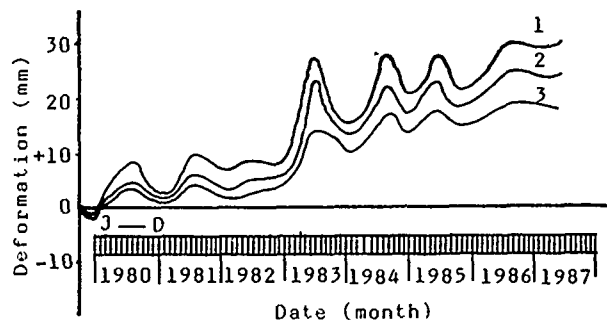
Fig. 5 Deformation Curves of Different Layers of Foundation Soil

In Figure 5: 1 = 0.5m Depth under ground  
2 = 1.5m Depth under ground  
3 = 3.0m Depth under ground

The deformation curves are as Figure 5.

In Figure 5, it's clear to see that with the reopening of the foundation soil layer, the vertical deformation magnitude would be reduced gradually. It's very evident that they'll go up and come down in synchronism.

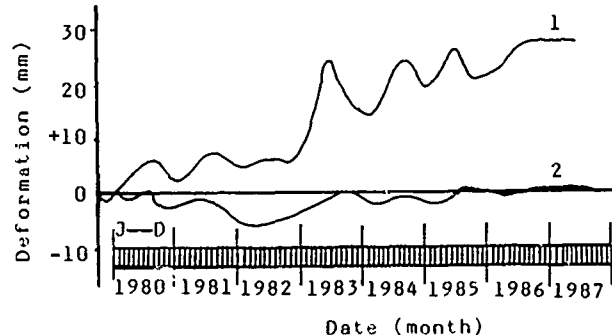
Fig. 6 Comparison of the Foundation Soil Deformation with the Building Deformation

In Fig. 6: 1 = Deformation curve of the foundation soil  
2 = Deformation curve of the building

The comparison of the deformation curve of the foundation soil in 1m deep with the deformation curve of building observation post 11 shown in Figure 6.

1. In the same depth, the building deformation range is only the 23 percent of the foundation soil deformation range.
2. In the spring of 1984, the foundation soil was subsided 11mm, but the building was subsided only 2.5mm.

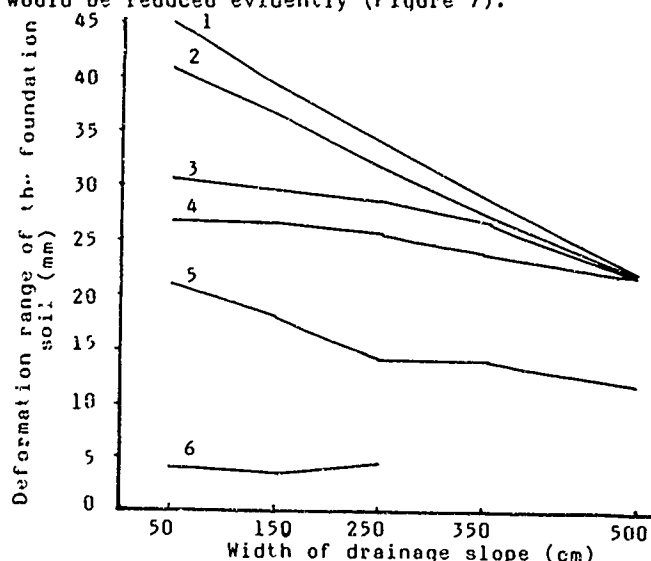
Fig. 7 Deformation Range Under Drainage Slope

- Curve 1 = Deformation of the foundation soil 0.5m under the ground surface
- Curve 2 = Deformation of the foundation soil 1.0m under the ground surface
- Curve 3 = 1.5m deep
- Curve 4 = 2.0m deep
- Curve 5 = 3.0m deep
- Curve 6 = 4.0m deep

The function of drainage slope may reduce the influence of the moisture content of the foundation soil caused by weather elements such as rainfall, temperature of atmosphere and earth's interior, and evaporation. So as to make the covering condition of both outside and inside building similar and reduce the deformation difference from inner and outer walls. Through the test and observation, it's improved that with the increasing of the width of the drainage slope, the deformation range of the foundation soil would be reduced evidently (Figure 7).

In Figure 7, it shows that it's obvious to reduce the deformation range of the foundation soil between 1 to 2m under the ground surface by drainage slopes. Thereafter, the buried depth of the foundation can be reduced by widening the drain-

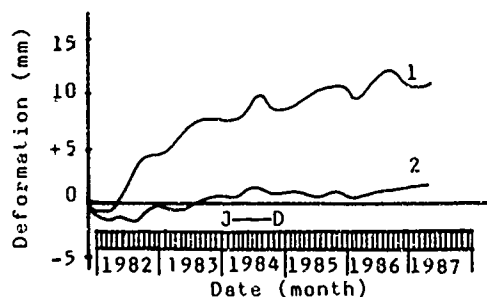
Fig. 8 Comparison of the Deformation

Curve 1 = Damaged buildings with deformation range of 13mm.

Since the end of 1981, the author had begun to conduct deformation observation untill March 1987. Figure 8 shows the comparison of the deformation of managed and damaged old buildings.

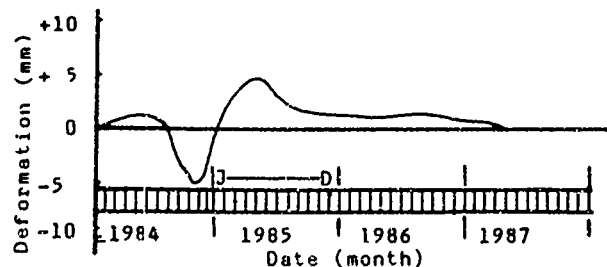
Fig. 9 Deformation Curve of the Building

The observation was begun in the January of 1984 and until the March of 1987, the maximum deformation range was 9.91mm and the building remains well (Figure 9).

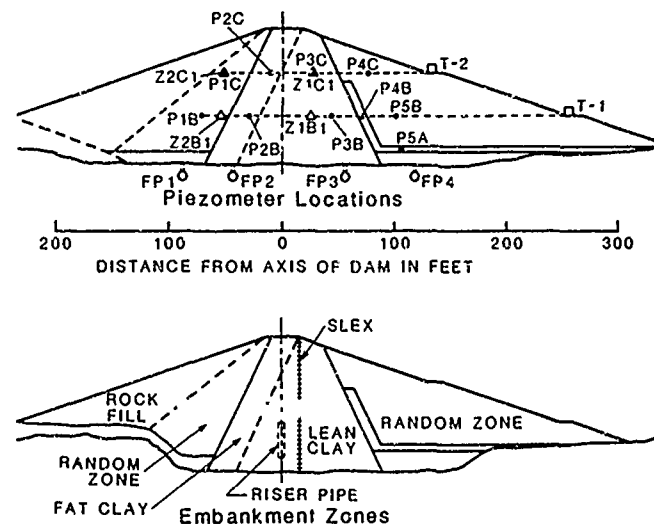
FIGURE 1: DAM SECTION STATION 10+00

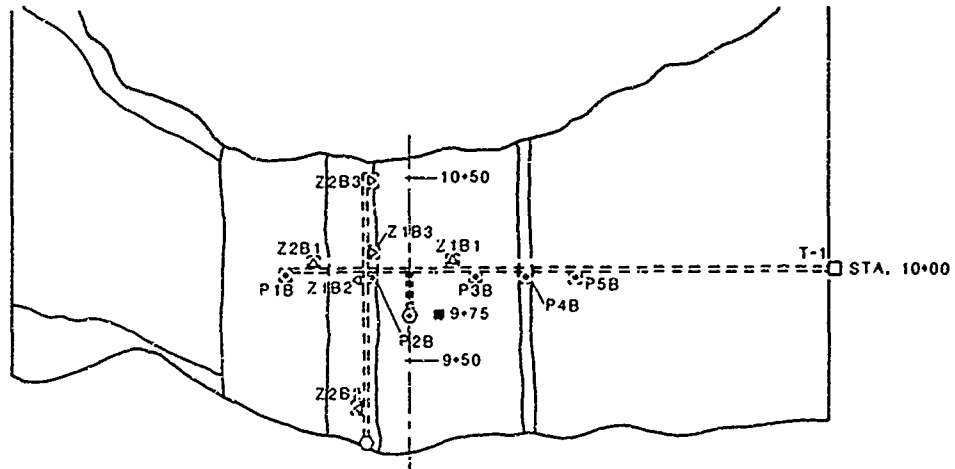
FIGURE 2: FOUNDATION AND ELEVATION 1031.5 INSTRUMENTS

Plan El. 1031.5

Plan El. 1004

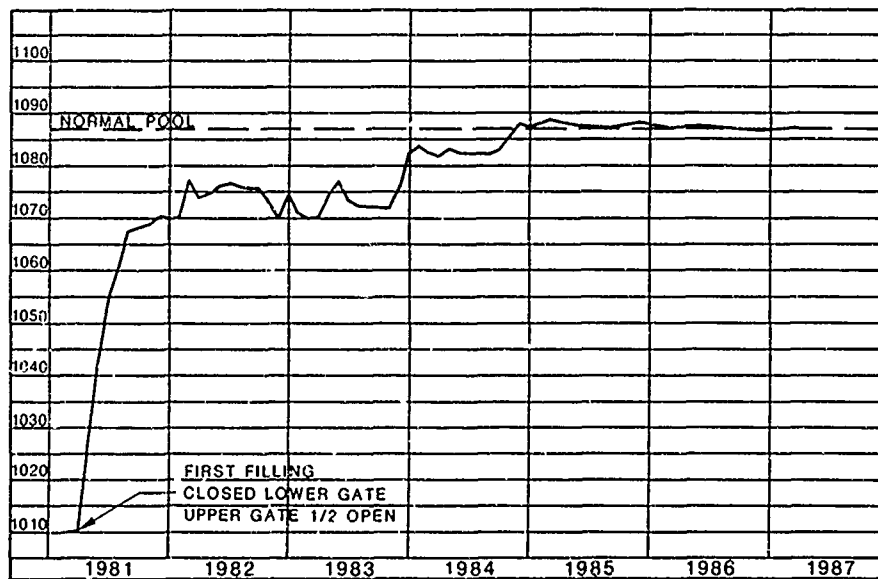
FIGURE 3: COUNCIL BLUFF LAKE - Water Elevation Vs. Time

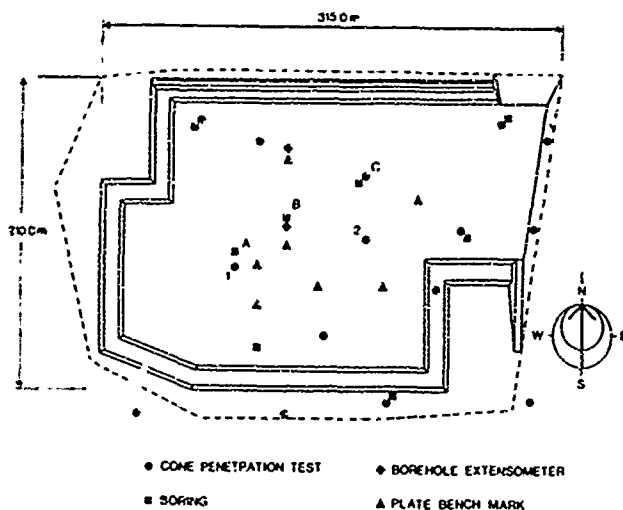
FIG. 2 - General plan of the preloading embankment.

Figure 2 shows the general plan of the preloading embankment and figure 3 shows a cross section of the embankment side berm built in order to ensure the stability of the embankment itself.

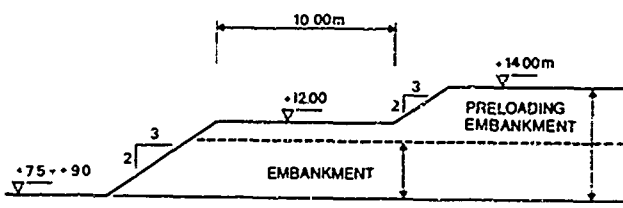
FIG. 3 - Cross section of the preloading embankment. Sea level has been taken as + 10.0 m.

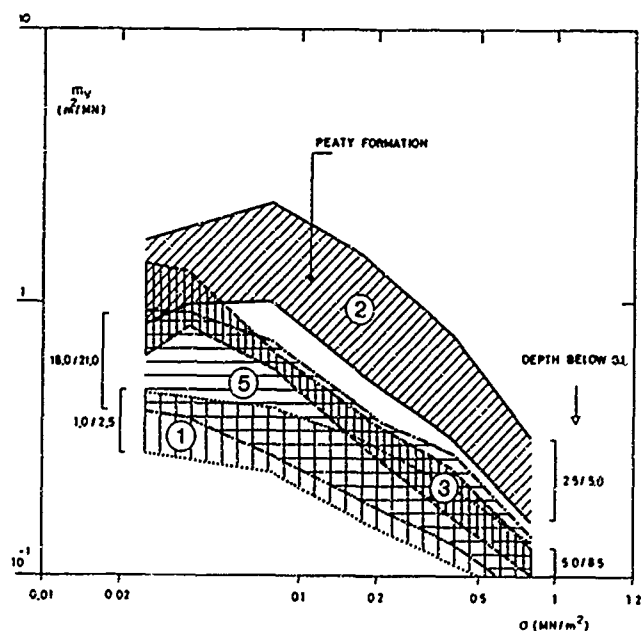
FIG. 4 - Trends of the  $m_v$  values of various formations vs. vertical effective stress.

Figure 4 shows the values of  $m_v$  as a function of effective stresses. The parameters for the settlement calculations have been chosen as function of geostatic stresses  $\sigma'_{v0}$  and of vertical stresses induced by overloading  $\sigma'_{v0} + \Delta\sigma'_v$  and calculation was carried out considering the hypothesis of monodimensional consolidations, which correspond to the geometry of the case examined.

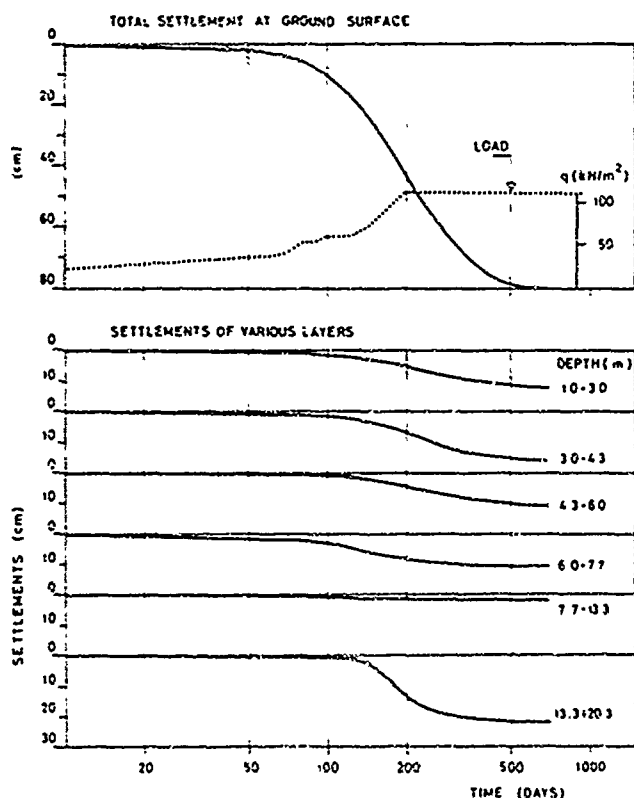
FIG. 5 - Trends of vertical settlements vs. consolidation time.

the embankment area, summarizes the settlement pattern in time of the foundation plan, and of the various layers, obtained through the difference measurements given by deep settlements gauges. The deep settlement gauges showed that soils at a depth greater than 30 m from ground level are responsible for a portion of the settlement equal to about 5 - 10 percent of total settlement.

Figure 5, referring to a central point of

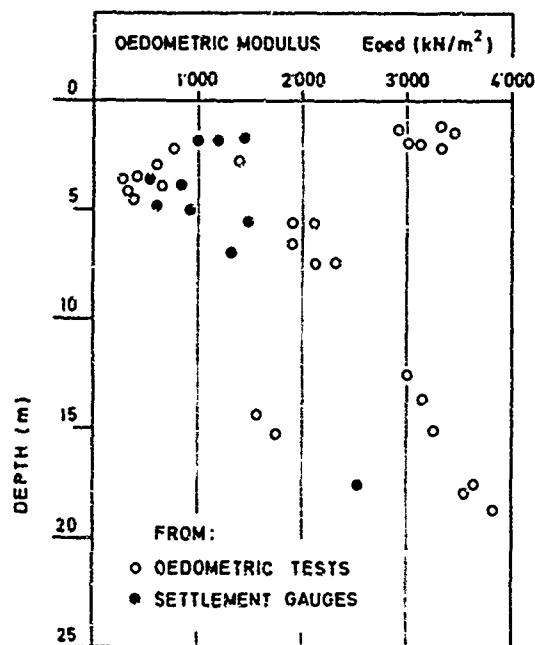
FIG. 6 - Comparison between in situ and in the laboratory constrained moduli.

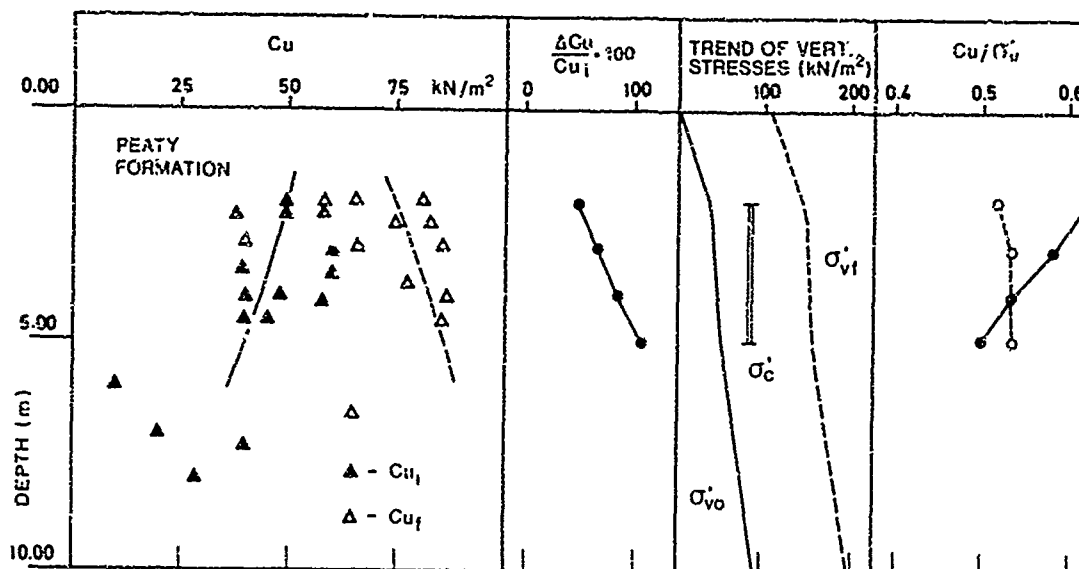
FIG. 8 - Variation of field vane strength in peaty formation as a consequence of increase in vertical effective stress.

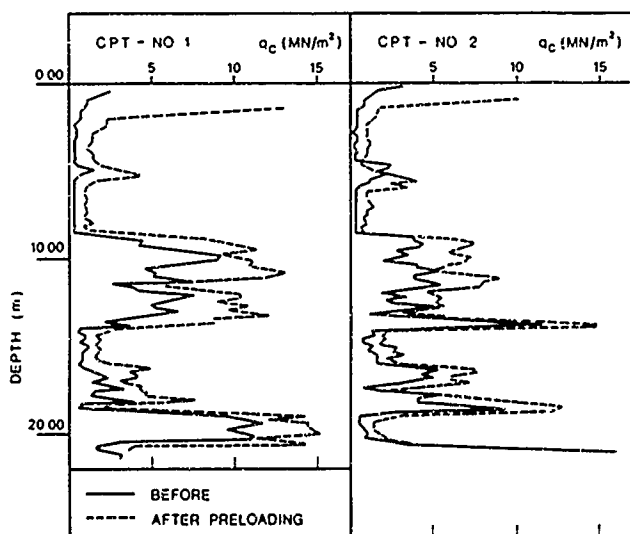
FIG. 9 - Results of two typical CPT tests before and after the preloading.

The static cone penetration test (CPT) has also been utilized to estimate the increase in strength consequent to increase in vertical effective stress and other stresses correlated to it. The increase in strength has been directly measured and correlated to the soil nature as reported below: two typical CPT tests carried out in the same position before and after the preloading are shown in fig. 9.

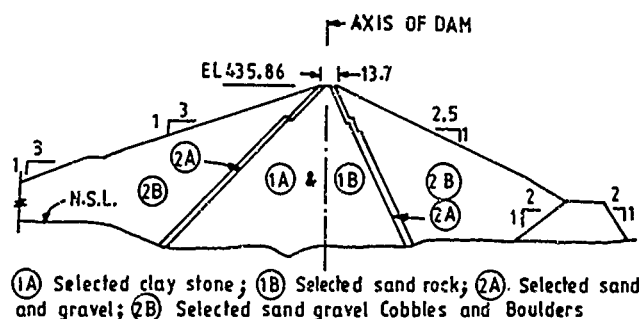
Fig.1 Cross-section of Beas Dam

Beas dam is situated in the Himalayan foot hills 19.3 Km. south of Kangra. It is a central earth core-gravel shell type dam with a maximum height of 132.5m. above the deepest foundation level, as shown in Fig.1.

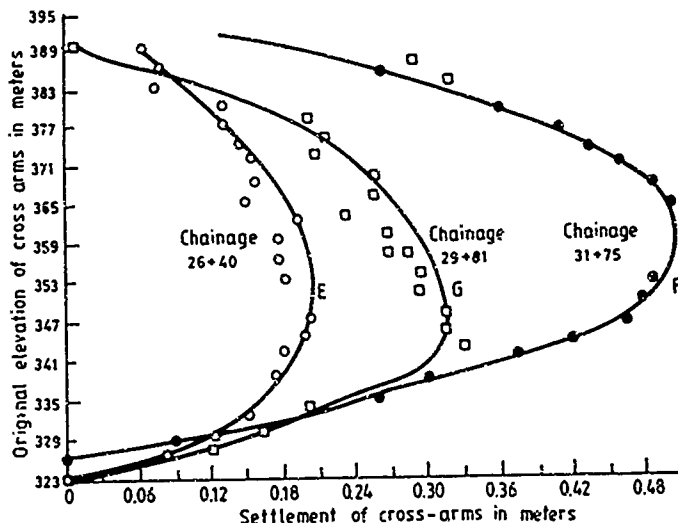
Fig.2. Settlements of Cross-arms in Beas Dam

Settlement of the individual cross-arm for each of the settlement devices has been plotted. It is observed that the maximum settlement have occurred in the device F which was embedded in the impervious core. During the early construction period compression was faster which slowed down with time. On an average 22.5 per cent of the total compression took place during the first one month after placement. Generally lower layers showed higher compression than the upper layers.

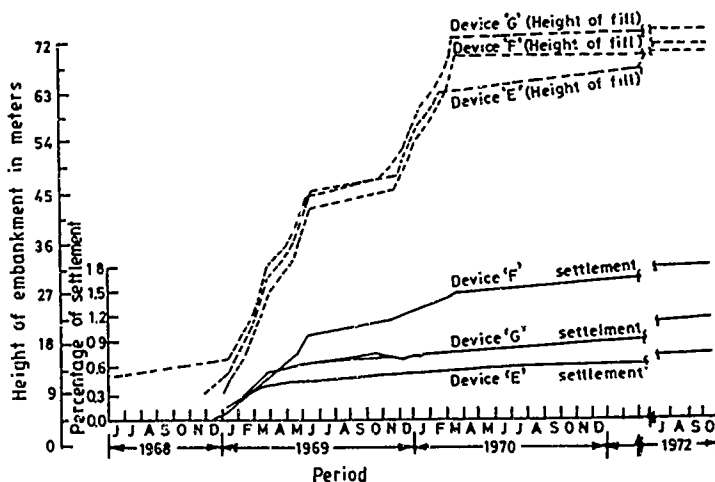
Fig.3. Settlement with Height of Fill in Beas Dam

The total settlement has also been plotted as the percentage of the height of the embankment fill height for the period of the raising of the embankment as shown in Fig.3. From this

plot, it is seen that the settlement curve largely follow the pattern of the fill placement curve with respect to time, (Ramamurthy 1984).

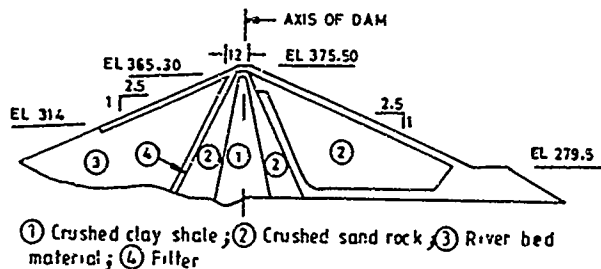
Fig.4. Cross-section of Ramganga Dam

The main earth and rockfill dam (127.5m high) constructed across Ramganga river at 3.2 Kms. upstream of Kalagarh in district Garhwal Fig.4.

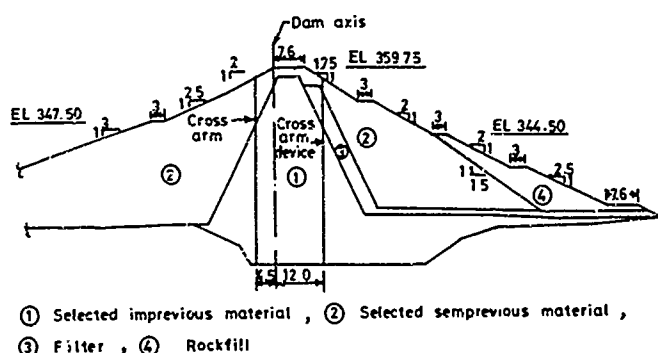
Fig.5. Cross-section of Tawa Dam

To measure compression within the embankment six USBR cross-arm devices coupled with horizontal movement plates were installed at three sections viz. 16.60, 36.35 and 44.10 as shown in Fig. 5.

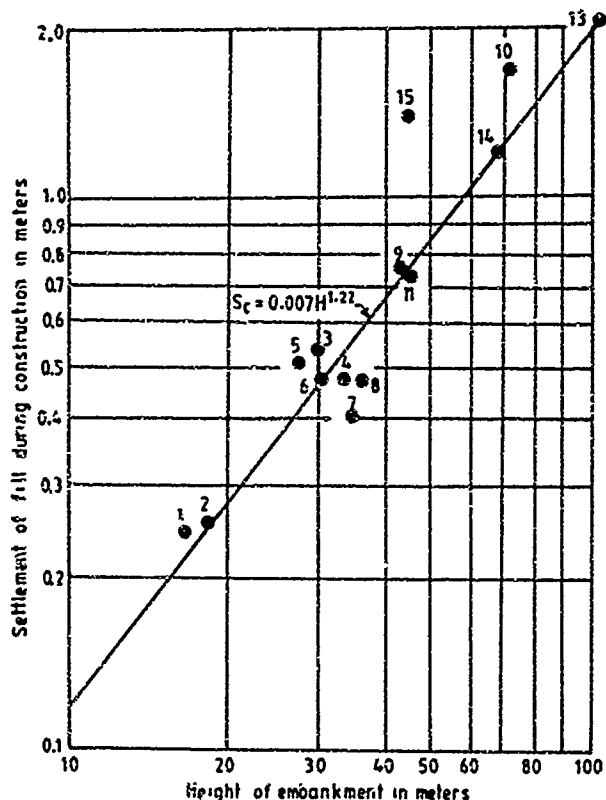
Fig.6. Settlement Variation during Construction with Fill Heights

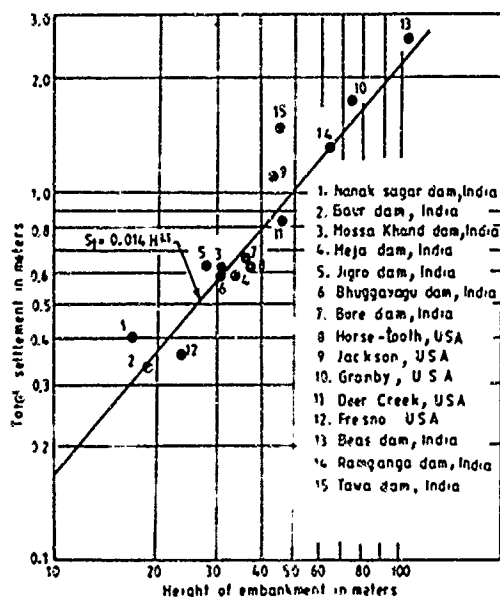
Fig.7. Variation of Total Settlement with Fill Height

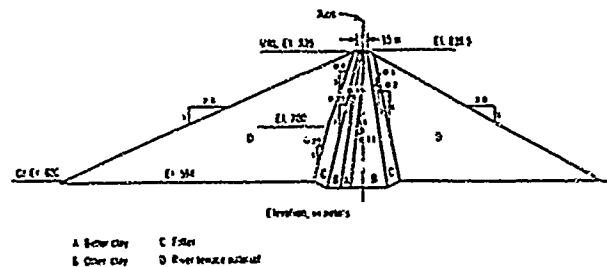
Fig. 3 - Initially Proposed Section

in Fig. 3, zone A was proposed to consist of better clay, with a PI greater than 7% and zone B, enveloping zone A, was to consist of clay from other borrow areas.

**Shape of Core** - Both the vertical and inclined cores have been provided in high dams. The core of the Mica Dam is also moderately inclined with an upstream slope of 0.4:1 and a downstream slope (sloping towards upstream) of 0.1:1; the core of the Oroville Dam has an upstream slope of 0.9:1 and a downstream slope (sloping towards upstream) of 0.5:1; and the core of Nurek Dam is a central core, with both upstream and downstream slopes of 0.25:1. The model studies carried out at the University of California in 1958 and at University of Roorkee in 1962 have indicated that an inclined core is somewhat more earthquake resistant. A vertical clay core was initially proposed for the section shown in Fig. 3. It was thereafter proposed to have a moderately inclined core for the dam, as shown in Fig. 5.

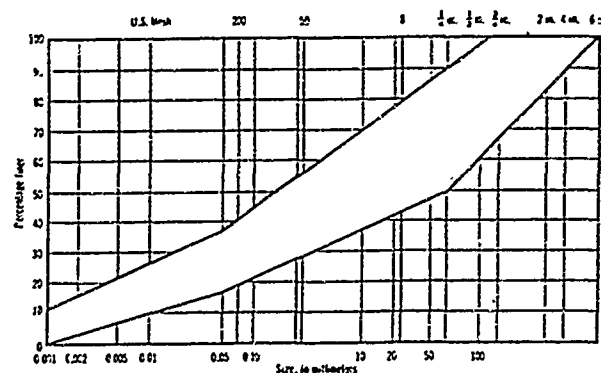
Fig. 4 - Proposed Gradation Envelope for Core Material

Further investigations for the dam fill materials suggested that in case the clay in the top layer of the river terraces is mixed with the underlying pervious material consisting of silt, sand, gravels, and boulders, a very good well-graded impervious material can be obtained for the core. The proposed gradation envelope of such a blended core material is given in Fig. 4. Such blended materials have already been used in the construction of the core of high dams like Nurek (309-m) in USSR, Mica (244 m) in Canada and Oroville (234 m) in the United States. In 1960 Bleifuss and Hawke recommended the use of a well-graded mixture of fine and coarse material for the core of the dam.

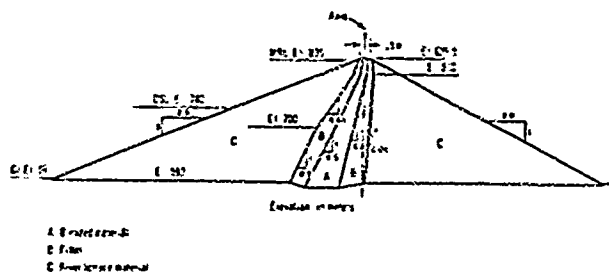
Fig. 5 - Proposed Section

The proposed dam section is shown in Fig. 5.

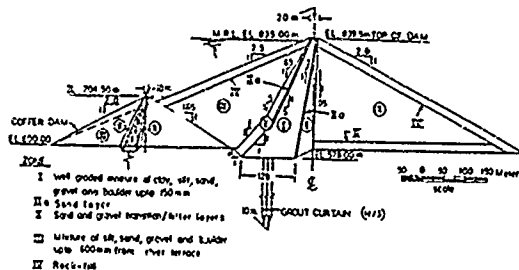
Fig. 6 - Main Dam and Cofferdam Section

**Thickness of Core** - Site investigations revealed the presence of sound rock in the river bed at EL 579 m. The core was therefore extended upto this level. Also, it was considered to have a seepage gradient of 0.5 and therefore the thickness of the core has been increased, as shown in Fig. 6, at the foundation contact level to 0.5H.

It was estimated that a 104.5 m high coffer dam would be needed to safe-guard against 1 in 1000 year frequency flood with a preceding flood of 1 in 25 year and 2.7 m freeboard. Fig. 6 shows the placement of the coffer dam as part of the main dam. Its upstream and downstream slopes are 2:1 and 1.85:1 respectively. There have been a number of exercises with various combinations of hydro-

There have been also suggestions for construction of concrete overflow section, below the core of the main dam, to serve as coffer dam or to reduce the fill quantities. There is yet another problem with the placing of coffer dam or the first stage dam as shown in Fig. 6. The axis of coffer dam, about 300 m upstream of the axis of main dam, would have all the problems anticipated for axis No. 2 of the dam as mentioned before.

Attempt has been made to estimate the non-recoverable deformations (1983) due to MCE, on the basis of evaluation of yield acceleration for rigid body movement of the sliding mass. As shown in the Fig. 13, only about 15.0 m and 10m depths of the upstream and downstream slopes are likely to be affected. Therefore, it has been proposed to place 20 m deep grade I rock (instead of gravel and boulder fill), which has angle of friction of about 45°. With this provision, as shown in Fig. 6, there is no likelihood of any slope deformation.

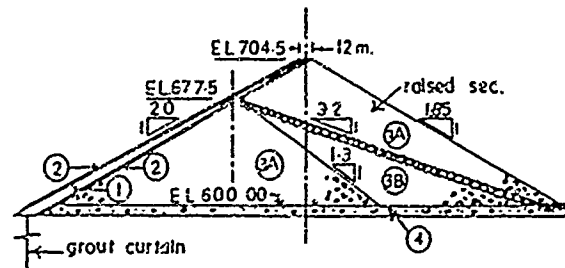
Fig. 7a - Overflow Section with u/s Blanket

logical parameters to determine the height of the coffer dam corresponding to 1 in 1000 year frequency flood and it has been found to vary between 85.0 m to 115.0 m. There have been discussions also regarding the design flood frequency and the decision has been in favour of 1 in 1000 year mainly because of not taking any risk for expected unprecedented flash flood in the absence of long-term hydrological data of the region. For the coffer dam section shown in Fig. 6, about 2.3 million  $m^3$  of fill is to be placed in one non-monsoon period of about six months in a very narrow gorge of the river. Corresponding to 1 in 100 year flood the fill quantities reduce to half. Alternate designs for placing the fill in two working seasons were worked out (upto et al., 1980). The sections were designed to withstand, (i) the overtopping (Fig. Nos. 7a and 7b) and, (ii) through flow and overflow simultaneously (Fig. Nos. 8a and 8b).

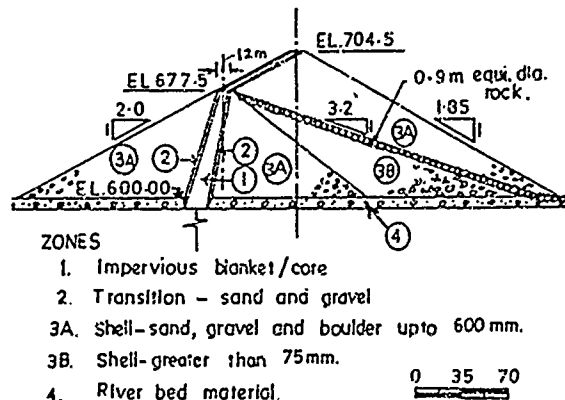
Fig. 7b - Overflow Section with Central Core

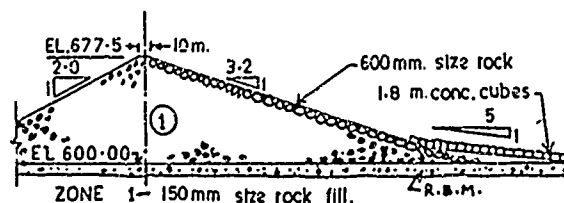
Fig. 8a - Through Flow Section

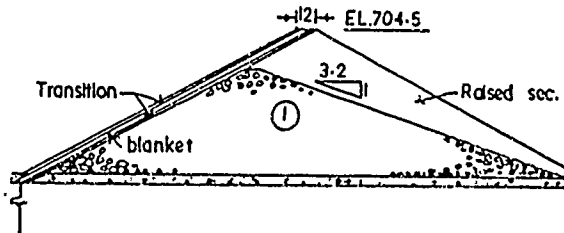
Fig. 8b - Through Flow Section with Raised Section and u/s Blanket.

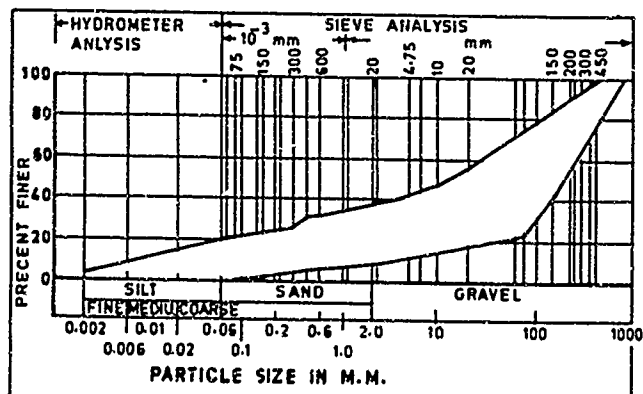
Fig. 9 - Gradation Envelope of Dobata Material

For determining the properties of fill materials, extensive sampling and testing has been done. In the borrow area for shell material (Dobata), 53 number of pits having depth of 9-10 metres were excavated (Gupta, et al., 1979). The gradation envelope of the material as in the borrow area is shown in Fig. 9. Initially the shear parameters of this material were determined by 30 cm x 30 cm size direct shear box. The maximum size of rock particle which could be used in the test apparatus was 25 mm only. The gradation curve for the specimen material was made in such a way that the curve for the coarser 70% of the material is parallel to that of borrow material as shown in Fig. 10. In order to find out the effect of particle size, plot was obtained for maximum particle size tested versus angle of friction value, as shown in Fig. 11. Extrapolation of this curve can

The shell material as available in borrow areas has quite high percentage of silt and sand (Fig.9). Though it has been decided to restrict the silt size particles to 6% by selective borrowing but still the development of excess pore water pressure during earthquake could not be ruled out without tests on such a material. Similarly, there could be development of excess pore water pressures in the core. Therefore tests were conducted (1983) on shake table by placing the material in saturated condition with desired density and subjecting it to the sinusoidal cycles equivalent to the MCE design time history. It was observed from these tests that there would be no excess pore water pressure development (and thereby reduction in shear strength) for more than 70% R.D.

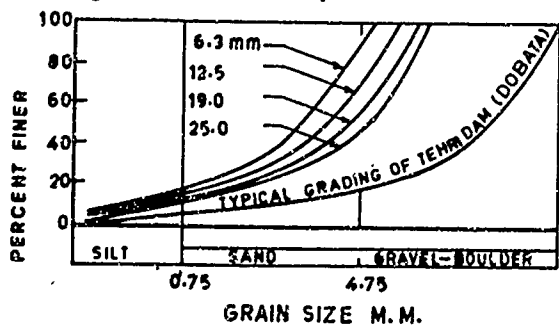
Fig. 10 - Gradation curves for Parallel Gradation Modelling Technique

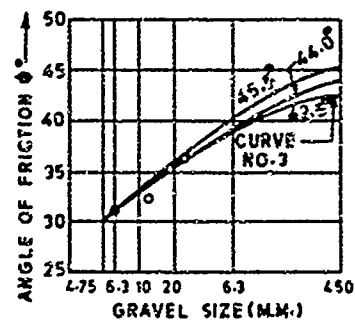
Fig. 11 - Extrapolation of Values Against Maximum Particle Size (I.R.I. 1977)

be done for higher sizes of materials along any of the three indicated paths. The lower most curve (No. 3) indicates angle of internal friction as 42.5°. The effect of confinement was later studied by conducting tests on 38 cm. dia size samples in the triaxial apparatus for shell and core materials (Lavama 1982). The angle of internal friction for the shell material (Zone III) adopted for the design is 38°. For core material friction angle is 27° and Cohesion 10 kilonewtons per square metre. For transition zone or filter layers friction angle adopted is 32°.

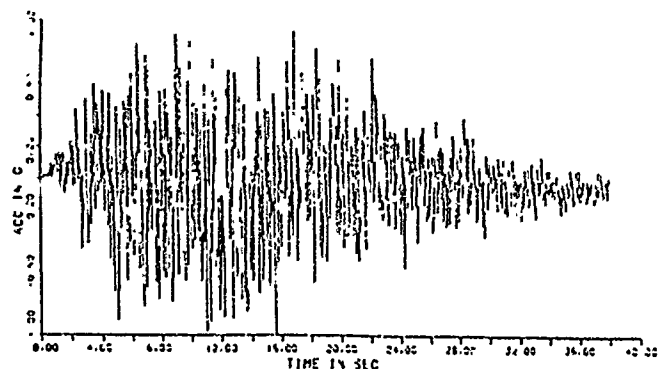
Fig. 12 - Artificial Earthquake for Tehri Site. Normalized to g.

**Seismic Condition** - The conventional pseudostatic analysis was also carried out along with nonseismic condition analysis and the outer slopes were fixed on the base of minimum safety factor of 1.5 and unity for nonseismic and seismic condition with seismic coefficient of 0.15. Thereafter, a number of studies were taken up for seismic stability of the dam. Design earthquake parameters were determined for the site (1983). Fig. 12 shows the normalised plot of the design time history for the site. The recommended values (max.) of design base earthquake (DBL) and maximum credible earthquake (MCE) are 0.125 g and 0.25 g respectively.

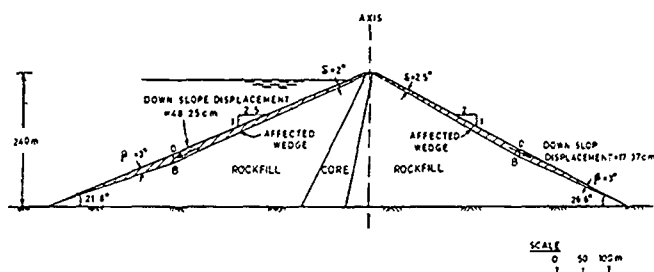
Fig. 13 - Affected Wedges of Dam

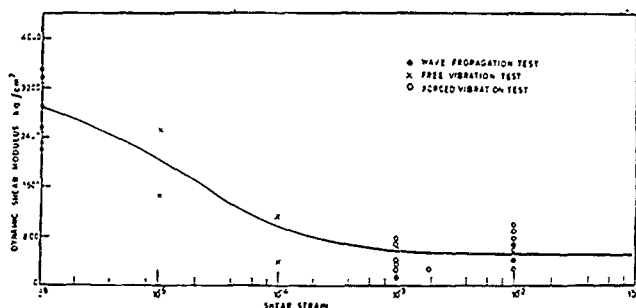
Fig. 14 - Dynamic Shear Modulus Versus Shear Strain (Dobata Material)

Tests were conducted at site on fill and foundation materials for determining the numerical values of dynamic shear modulus and damping coefficient. The plots of shear modulus versus strain level for the shell and core materials are

given in Figs. 14 and 15 (1983). The damping ratio of 10% has been adopted for these.

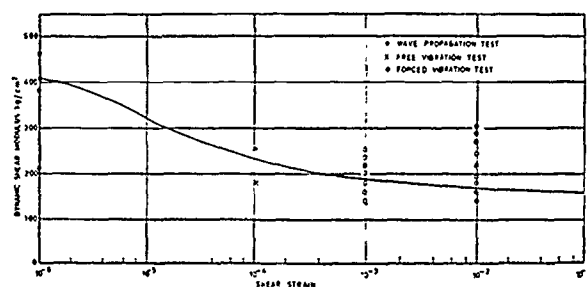
Fig. 15 - Dynamic Shear Mod. v/s Shear Strain, Core Material

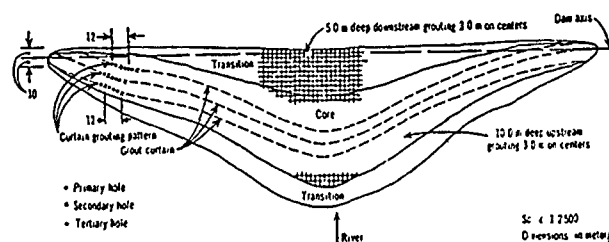
Fig. 16 - Foundation Grouting Plan

Area grouting for the core contact area and downstream fine filter has been planned at 3.0 m spacing 10.0 m deep upstream of the curtain and 5.0 m deep downstream. The foundation grouting plan is given in Fig. 16.

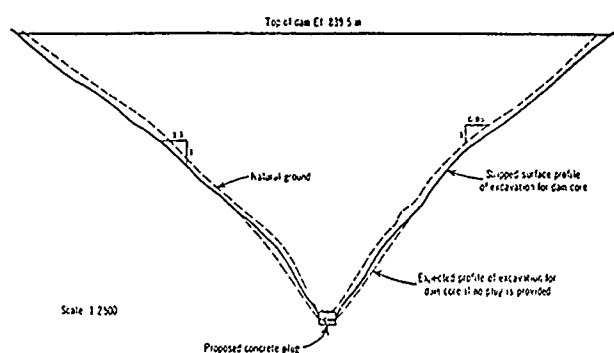
Fig. 17 - Proposal of Concrete Plug

**Abutment Easing** - As shown in Fig. 17, the gorge section has slopes of right and left abutments as 1.1:1 and 0.95:1, respectively. Therefore, it is proposed that the local steep slopes and overhangs if any, be eased at a slope of 70° (0.36H:1V), as was done at the Mica Dam. However, the depth of silt, gravel, and boulder-fill in the river bed is expected to be of the order of 10-15 m. The gorge in this depth is likely to have almost vertical walls. Therefore, considerable excavation may have to be done. Keeping this in view, another proposal, as mentioned in the following section on "Special Treatment", is under consideration.

**Concrete in River Section** - The abutments of the Tehri Dam are steeper than those of the Mica, Oroville, and Bennet Dams, and the water head is also greater than for these dams. However, the abutment slopes of the Nurek Dam (300 m) are of almost the same order, and the water head is also greater than that for the Tehri Dam. For the Tehri Dam, in case the excavation of abutments is done at the limiting slope of 70° from the core foundation level in the river bed, it would involve a huge excavation of the rocks and for a considerable height the abutment contact would be at a slope (70°) steeper than that available naturally from above the river water level. In the Nurek Dam, for a similar situation, it has been considered economically and technically sound to have the portion at the river bed filled with concrete (Odintov and Gladkov, 1971). This concrete block in the river bed, under the core contact area, is called a "concrete plug". It is 157 m long, 30 m-60 m wide, and accommodates three grouting galleries. Similar proposal (Fig. 17), with and without grouting galleries have been proposed for the Tehri Dam.

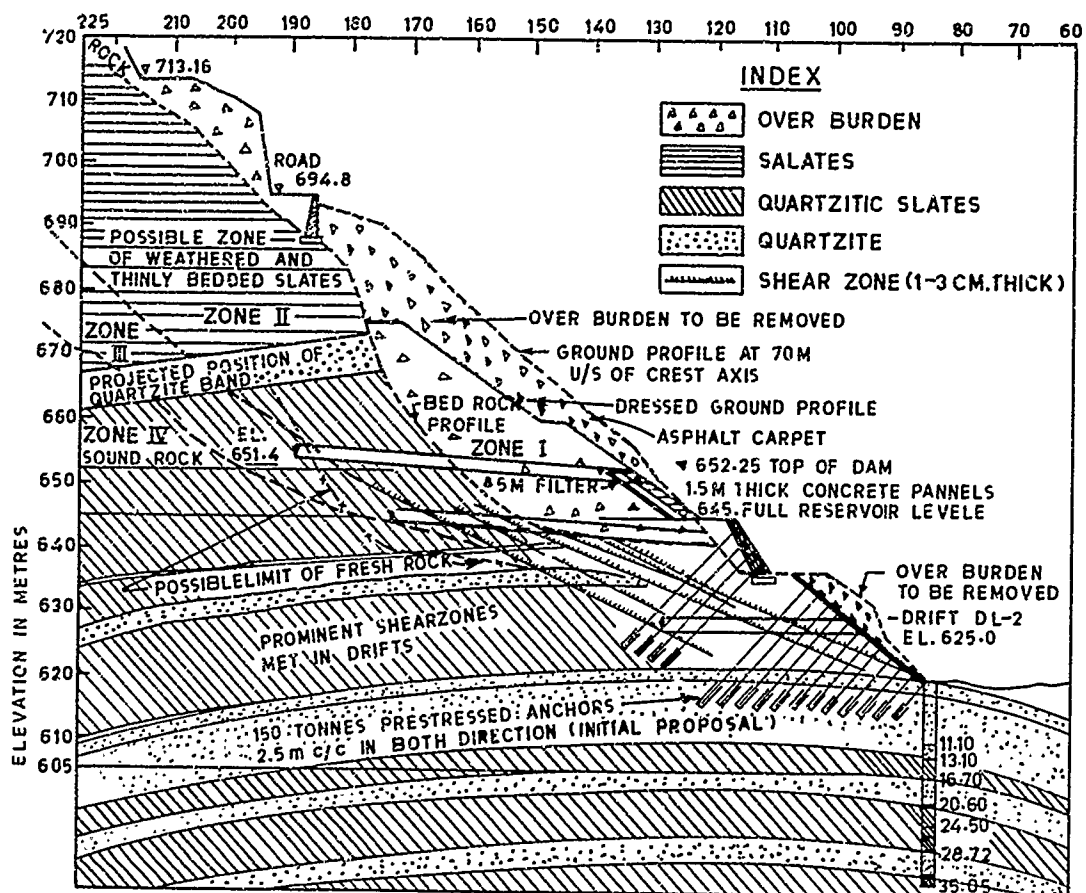
FIG. 1 - Geology at Section 70.m Upstream of Dam Axis (with Initial Proposal of Steel Anchors)

The existence of these geological features had created the problem of ensuring the stability of the left bank slopes and also of tying the dam securely to the left bank rocks. The solution of the first problem only is described in the paper. The slopes upstream of the dam axis, comprising of overburden material and the rock mass below it were found, by analysis, to be in a state of limiting equilibrium. The construction of the dam had to raise the water level from the general elevation level of about 612.0m to 644.75m (toe submergence). Also for peaking on the power houses daily there has to be drawdown in the reservoir from EL 644.75m to EL 636.0m, in a very short duration of about 4 hours. These situations had to bring down the stability of the hill mass. The condition of the slopes on the downstream of the axis did not materially change after the construction of the reservoir and therefore did not require as elaborate treatment as for upstream slopes.

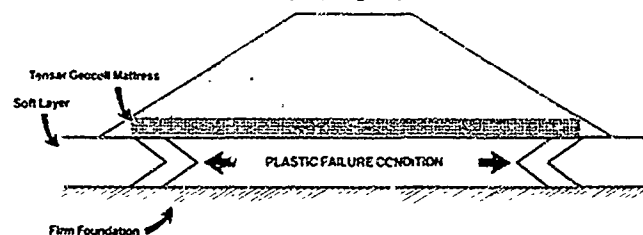
Figure 4

A Geocell mattress is a very stiff rigid foundation mattress designed to support an embankment over very soft ground. It is generally installed at existing ground level and with no soil strip (Fig 4).

The mattress is constructed from high strength Tensor geogrids to form a cellular construction.

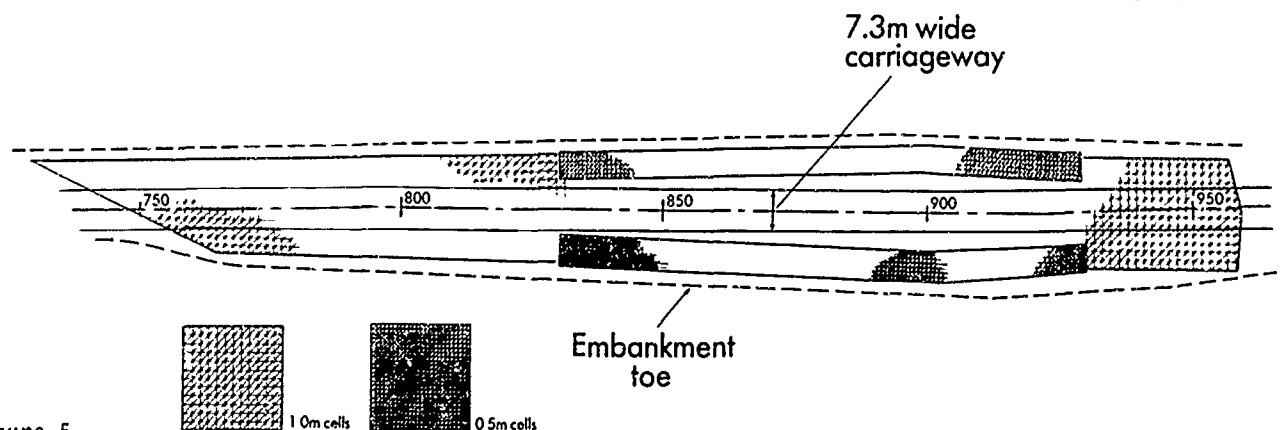
Figure 5

The mattress required to be edge stiffened over the outer 6.0m. This was achieved by using 0.5m cells along the outer edges and conventional 1.0m cells within the remainder (Fig 5).

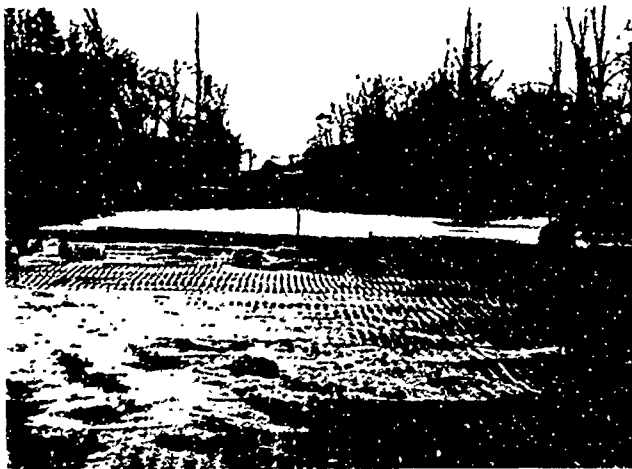
Figure 6

4.0m wide lengths of Tensar SS2 were rolled out along the line of the road to form the base of the mattress. These strips were lapped by 500mm. The main transverse diaphragms were Tensar SR2 and were installed at 1.0m centres across the mattress. The Tensar SR2 was stitched to the base material using HDPE braid (Fig 6).

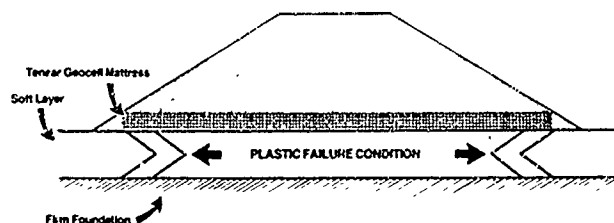
Figure 10

This considers the plastic failure of material compressed between two rough, rigid parallel platens being brought together. The platen widths exceed the soft material layer thickness (Fig 10).

The Geocell mattress represents the upper platen with the weathered mudstone representing the lower.

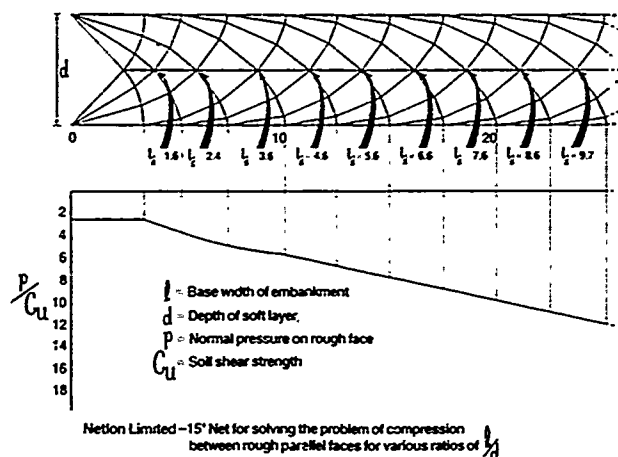
Figure 11

Load distribution on the base is obtained from the equations given in the extract from "Engineering Plasticity" and from the 15 degree flow net (Fig 11).

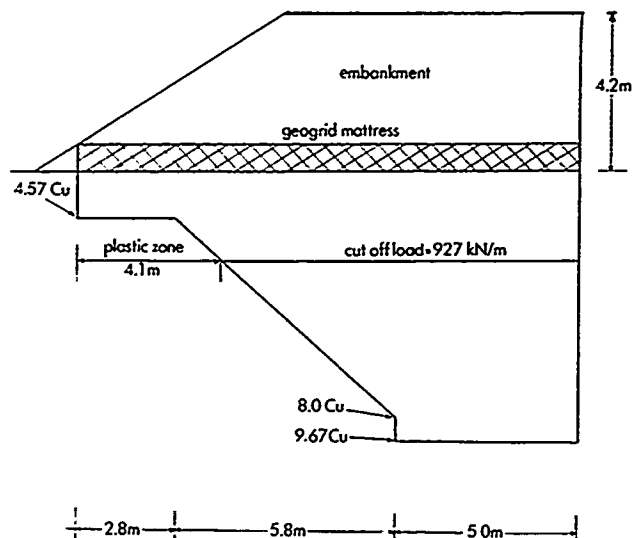
Figure 12

Therefore, adopting an average cohesion of 15.0 kN/sq m for the soft layer, the load to failure for the half embankment is (Fig 12):-

The embankment load/foundation diagram is shown in Fig 12. The cut off line at support value of 927 kN/m shows the extent of the plastic zone.

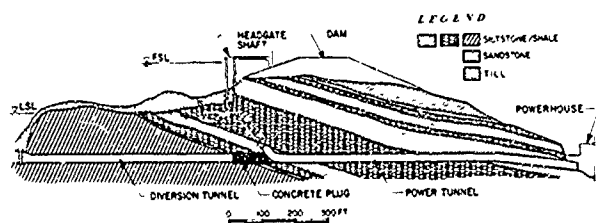
The Blackstone Formation forms the upstream segment of the canyon and descends downstream below riverbed level beneath the Bighorn Formation which predominates within the abutment areas of the dam as shown on Figure 3. The contact between the two formations dips conformably with

Fig. 3 Section through north abutment

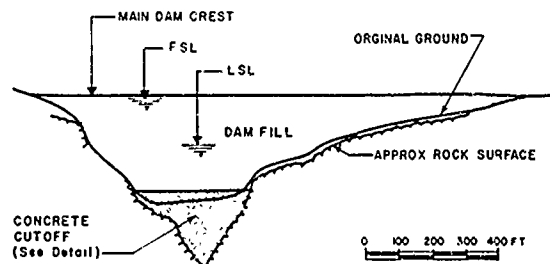
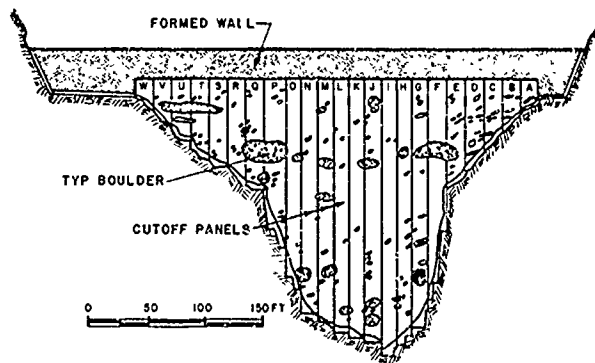
The downcutting which formed the canyon extended through the cover of glacial drift, the Wapiabi and Bighorn Formations and into the Blackstone beds to a total depth of about 560 ft. Drilling in the valley floor indicated infill deposits extending to a maximum depth of 216 ft and consisting mainly of interbedded, river-sorted, silty to relatively clean sands and gravels in varying proportions, interspersed with bouldery talus from the canyon walls. It is noteworthy that the investigation of the bed was satisfactorily accomplished only with the advent of the Becker hammer drill, though it was difficult to appraise the consistency of the finer granular deposits and several lines of closely-spaced holes were needed to distinguish the massive boulders from the parent intact rock. The bedrock profile along the axis of the cut-off wall, and the boulders encountered, are shown on Figure 4.

(a) Longitudinal Section

(b) Cutoff Detail

Fig. 4 Concrete cut-off construction

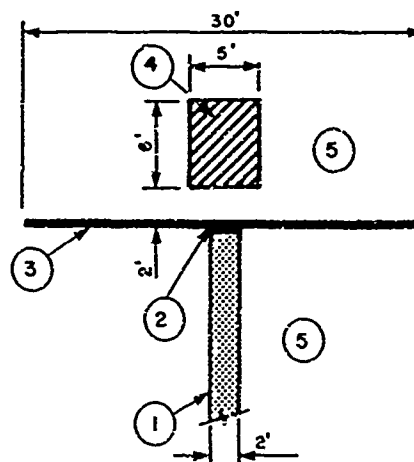
The adoption of the diaphragm wall was based on the confidence expressed in its suitability by Dr. A. Casagrande who, together with Dr. R.M. Hardy, provided specialist geotechnical expertise to the project. To counter the effects of any disruption of the core arising from settlements relative to the wall, the wall was capped with a 30 ft wide galvanized steel plate surmounted by a 5 ft wide trench centred over the wall and filled with bentonite, as shown on Figure 5. As it was anticipated that differential heads across the wall exceeding 100 ft

1. CONCRETE CUT - OFF WALL
2. NEOPRENE
3. STEEL PLATE
4. BENTONITE FILL
5. IMPERVIOUS CORE

Fig. 5 Detail of cap at top of wall

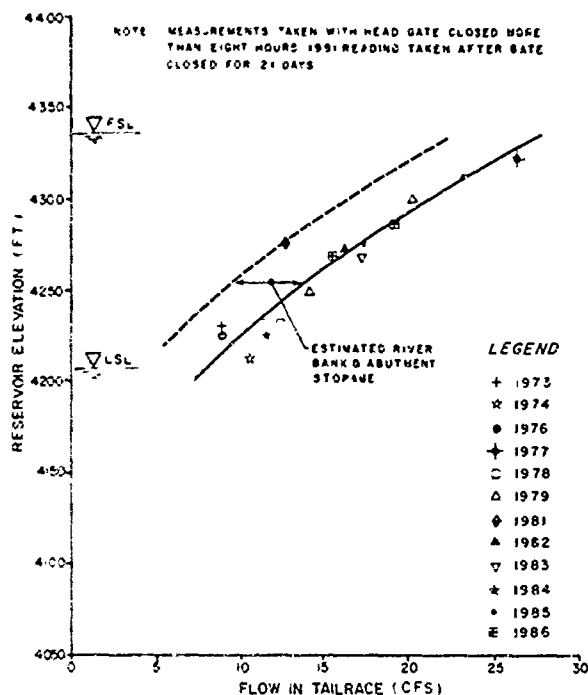
Fig. 6 Variation in seepage with reservoir level

Seepage - As indicated by flow measurements from Weir 1, located between the downstream toe of the dam and the tailrace (Figure 1), the variation of seepage flows with reservoir elevation since first filling of the reservoir is reasonably consistent indicating no major increase in seepage with time. However, since a significant portion of the total dam and foundation seepage is flowing through the river bed alluvium under the weir, it is possible that reasonably large variations in total seepage may occur before a change in Weir 1 flows is observed. Maximum seepage flows as determined from stream gauge measurements taken in the river channel downstream of the powerhouse when the tunnel headgate is closed have reached 28 cfs (Figure 6) whereas the peak flows recorded at Weir 1 have been about 3.5 cfs. The flow values for different reservoir levels given on Figure 6 represent stream gauge readings taken at least 8 hr after headgate closure to minimize the effect of riverbed and abutment storage outflow at lower river levels. However, outflow from riverbed and abutment storage is a significant component of the measured flows as indicated by the 1981 reading taken 21 days after gate closure.

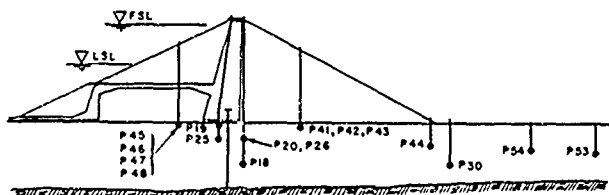
**Piezometric Records** - Only five standpipe piezometers upstream of the cut-off have remained operational since 1972 to monitor piezometric heads in the river bed alluvium. Of these P25 is located 30 ft upstream of the wall and the tip is set approximately 60 ft below the original river bed (Figure 7). The other four, P45 through P48 inclusive, are collared on a berm on the upstream slope about 135 ft from the cut-off wall and are set just below the contact between the dam fill and the native gravels.

Fig. 7 Relative locations of foundation piezometers
